National Register of Historic Places Registration Form

3. State/Federal Agency Certification		
Street & number: 201 West Broadway City or town: Enid State: OK Cou Not For Publication: Vicinity:	unty: Garfield

2. Location		
(Enter "N/A" if property is not part of a multiple property	ty listing	
Name of related multiple property listing: N/A		
Other names/site number: N/A		
Historic name: <u>Security National Bank Building</u>

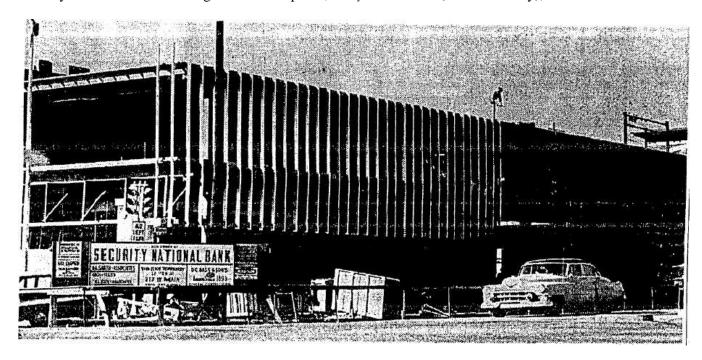
Fig. 1

Security National Bank Building construction photo, Daily Oklahoman (Oklahoma City), 7 October 1961.

The facades are created as two different, stacked, horizontal volumes, relieved by the slender posts in the first story and the vertical mullions in the second story. In the north elevation the first story carries a signature element, transparent glass walls that make the second story appear to sit on a void and thin posts. In the east elevation the wall is primarily smooth, white marble. In the primary and secondary elevations the second story is slightly cantilevered, projecting over the first story approximately 12 inches. In both north and east elevations the second-story wall carries the building's other signature, innovative, elements; the curtain walls are created by a system of porcelain-enameled steel panels attached to vertical aluminum mullions that are attached to the outside of the building's steel superstructure in a "stick system" construction method. It appears that the aluminum mullions were fixed to the steel beams all the way across the elevation, a grid was installed between the mullions, and the steel panels were fixed between the mullions (as illustrated in a 1961 historic photograph; refer to Fig. 1, Security National Bank Construction photo, Continuation Sheet 7/1).

Innovative construction technology, methods, and materials, as used in the SNB Building, were successful but were not without issues. The gauge of the steel used in wall panels proved to be important. In the process of building Security National, construction company owner H. B. Bass noted that the gauge was initially too light, and that "something happened to the beautiful, up-to-date exterior skin wall panels. They warped after being put into place and months elapsed while they were removed and replaced with the present highly satisfactory material." The superstructure allowed the bank's interior design to be open, with a voluminous lobby. The outside walls were banked with interior-window offices. Upstairs, on the second floor, offices were arranged on either side of a central hallway. The second-floor office areas were leased to private concerns. As soon as SNB was completed, its architect, Dura A. Smith, relocated his office there from the nearby Bass Building. 14
