# National Register of Historic Places Registration Form

Historic name: Hamilton Cross Farmhouse

Street & number: 1509 West Ninth

City or town: Stillwater State: Oklahoma County: Payne

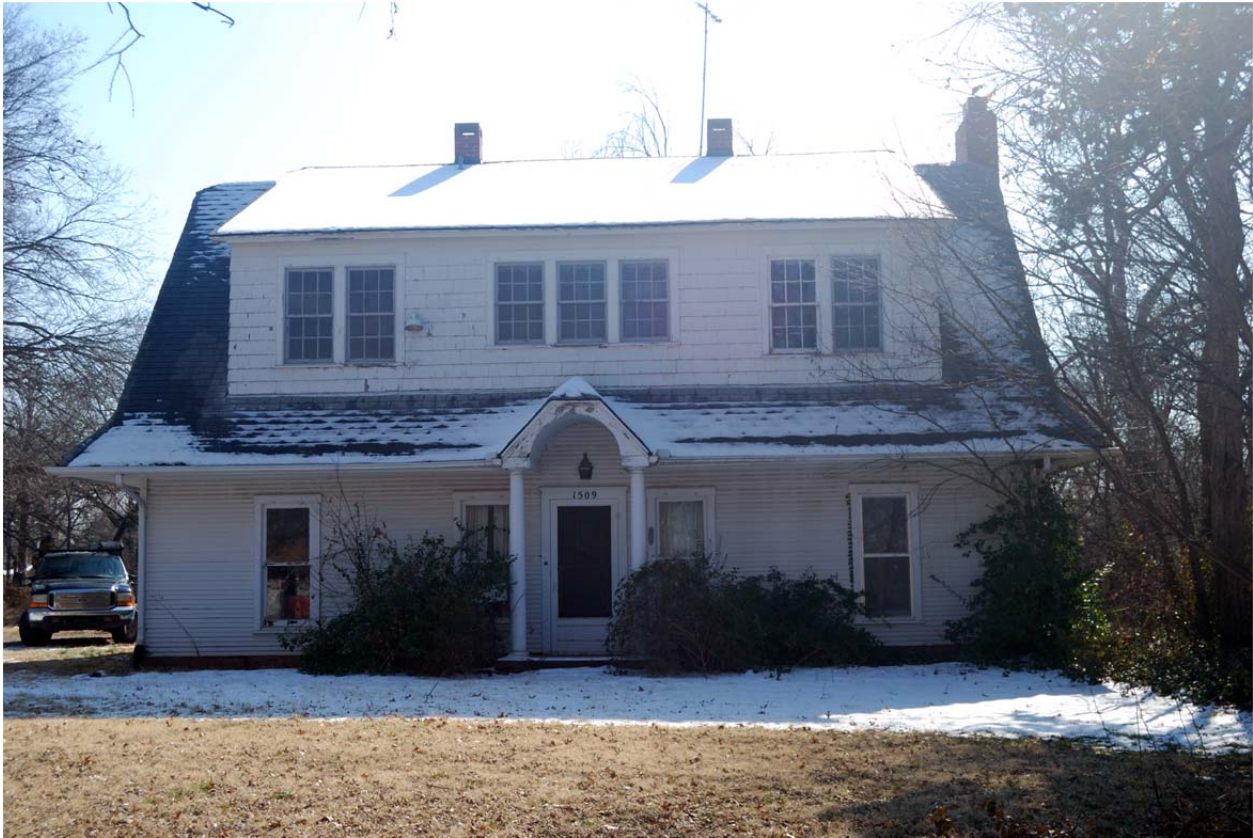
The façade, north elevation, has a centrally located door that is covered by a front facing gable porch roof. Two slender columns support the porch roof. Located on either side of the entry are two one-over-one double hung wood windows. Located in the steeply pitched gambrel roof, on the second floor, is a continuous shed roof dormer. Located in the center of the dormer are three smaller six-over-six double hung wood windows. Located on either side of the three windows are two larger six-over-six double hung wood windows. Two small brick chimneys are located along the ridge.

The identifying characteristics of the Colonial Revival style can be identified on this house. The most significant characteristic is the accentuated front door with a pediment supported by columns which create an entry porch. Another important defining characteristic is the use of symmetry. The primary façade demonstrates balanced symmetry in the window placement, door placement and dormer placement.

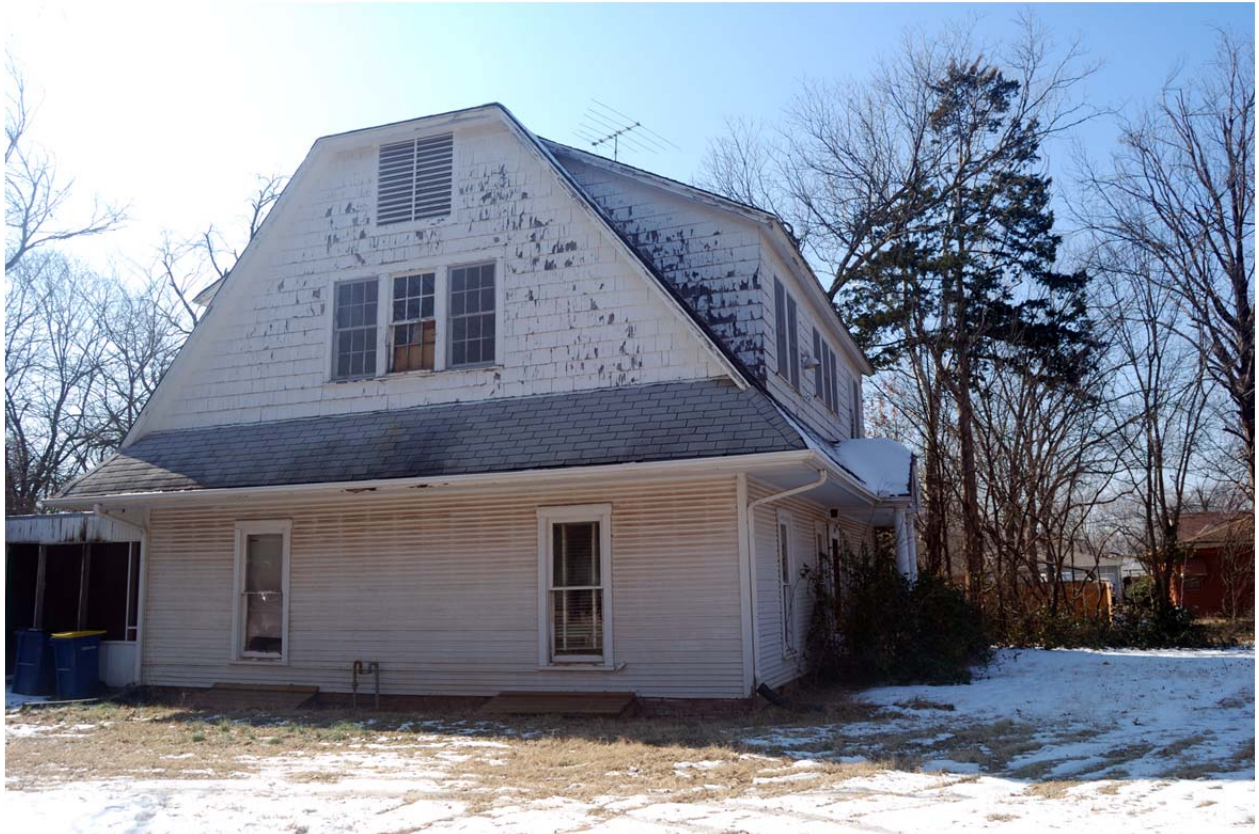
The east elevation has two one-over-one double hung wood windows on the first floor. Between the first and second floors is a shed roof creating a large soffit. Located in the gambrel end, on the second floor are three six-over-six double hung wood windows. Located in the clipped gambrel peak are two louvered vents for the attic space.
